# DSP56371E Digital Signal Processor

## Mask 1L41N

### Silicon Errata

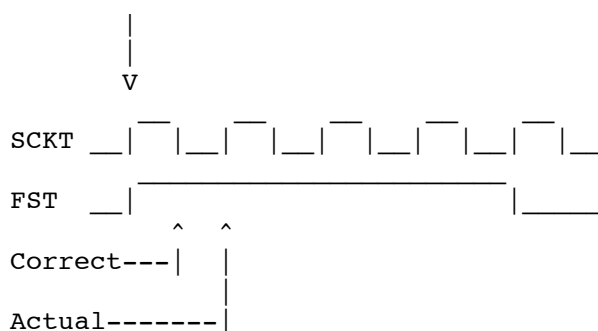
When providing an external word length FST and bit clock (SCKT) to the ESAI transmitter, the transmitter may lose the first bit if the SCKT clock trails the FST. It is important to maintain equal length signal paths for both the FST and SCKT clocks in slave mode.

FST and SCKT should be synchronous as shown by the arrow at the top of the following figure.

The correct time to latch the FST is on the falling edge when the clock polarity bit is clear. However, when SCKT trails FST it is actually being latched on the following rising edge as shown.

If the ESAI inputs the FST rising edge before the SCKT rising edge that generated it then it will "skip" a bit and assume the first bit has already been driven and start to output the second bit. The ESAI would be one bit ahead of the external device.

**Workaround:** The SCKT clock should be synchronous with the FST clock and should not trail it when the ESAI transmitter is in slave mode.
